Accident Investigation and Reconstruction
11740 Airport Way, Hangar35D
Broomfield, Colorado 80021
Phone: 303-438-8230
Fax: 303-438-8510
Email: hangar@airinc-co.com

I am submitting this report in the matter of Daniel McGraw and Susan McGraw vs. Superior Aviation, Ltd., Kubick Aviation Services, Inc., and QBE Insurance Corp.

ACCIDENT BRIEF

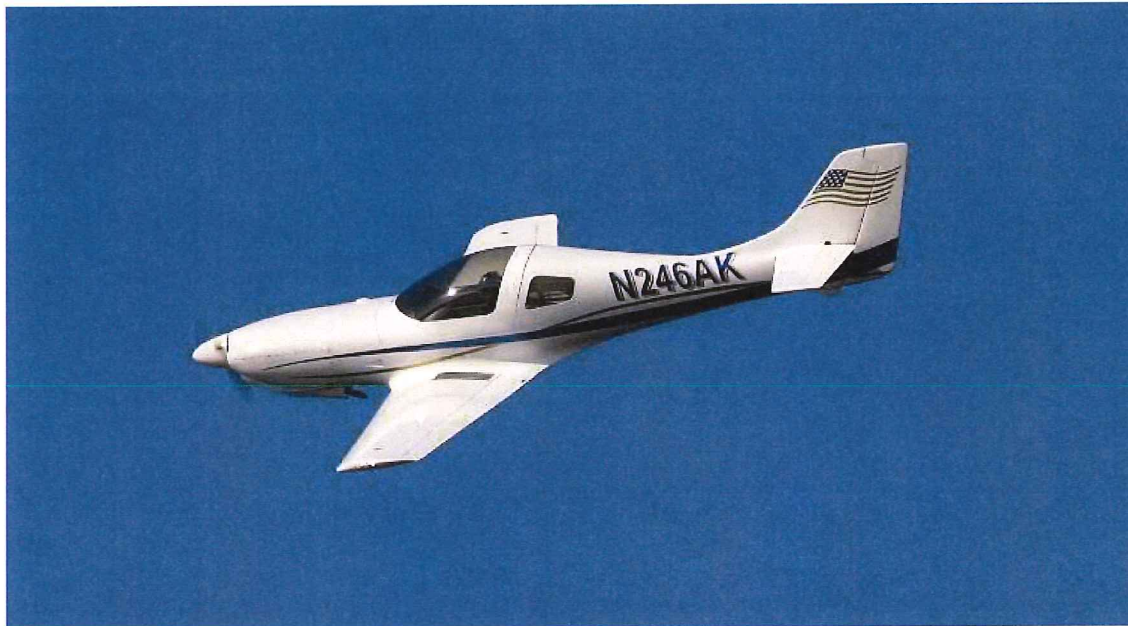
Figure 1 below is a photograph of the accident aircraft.

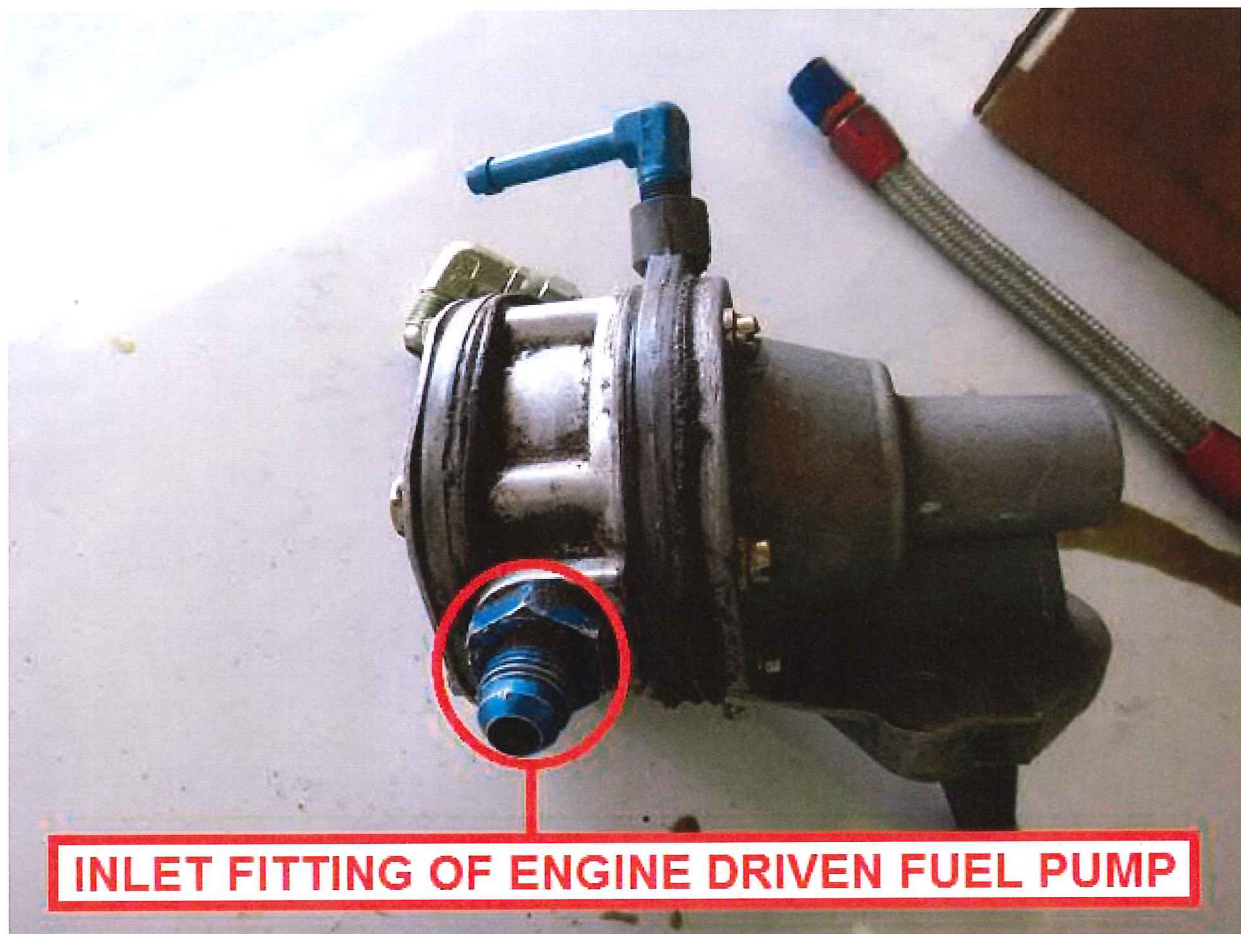
The accident aircraft landed in a cornfield in the upright position. An FAA Inspector examined the aircraft at the accident scene. The fuel supply hose was reportedly not attached to the engine driven fuel pump. Figure 2 is a photograph of the engine driven fuel pump.

Of specific concern to me was how the fuel pump flex hose became detached from the pump. My own forensic examination of the fuel pump and hose revealed that the pump installation incorporated an aluminum fitting while the flexible hose has a steel B nut.

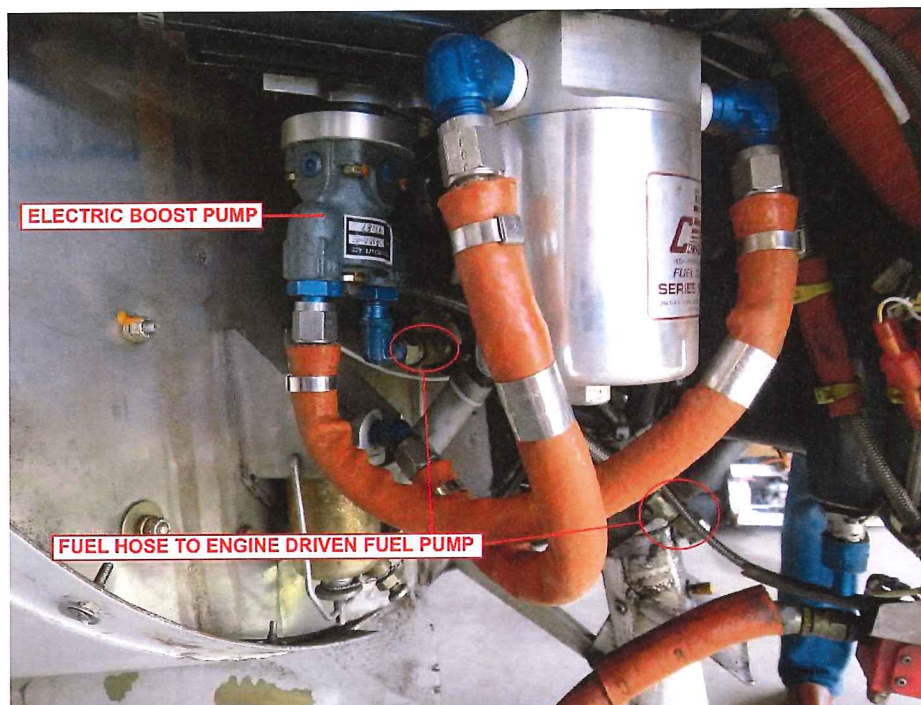
Figure 3 is a photograph of the inlet and outlet hoses from the engine driven fuel pump.

In this accident, the aluminum fitting did not crack, however, it did loosen and detach, which is a specific form of fatigue caused by vibration. The use of dissimilar metals in the connection can also lead to a loosening of the connection.

This accident was caused by the fatigue failure/disconnection of the inlet fuel line to the engine driven fuel pump due to the use of improper materials by someone other than Superior, most likely the original manufacturer.

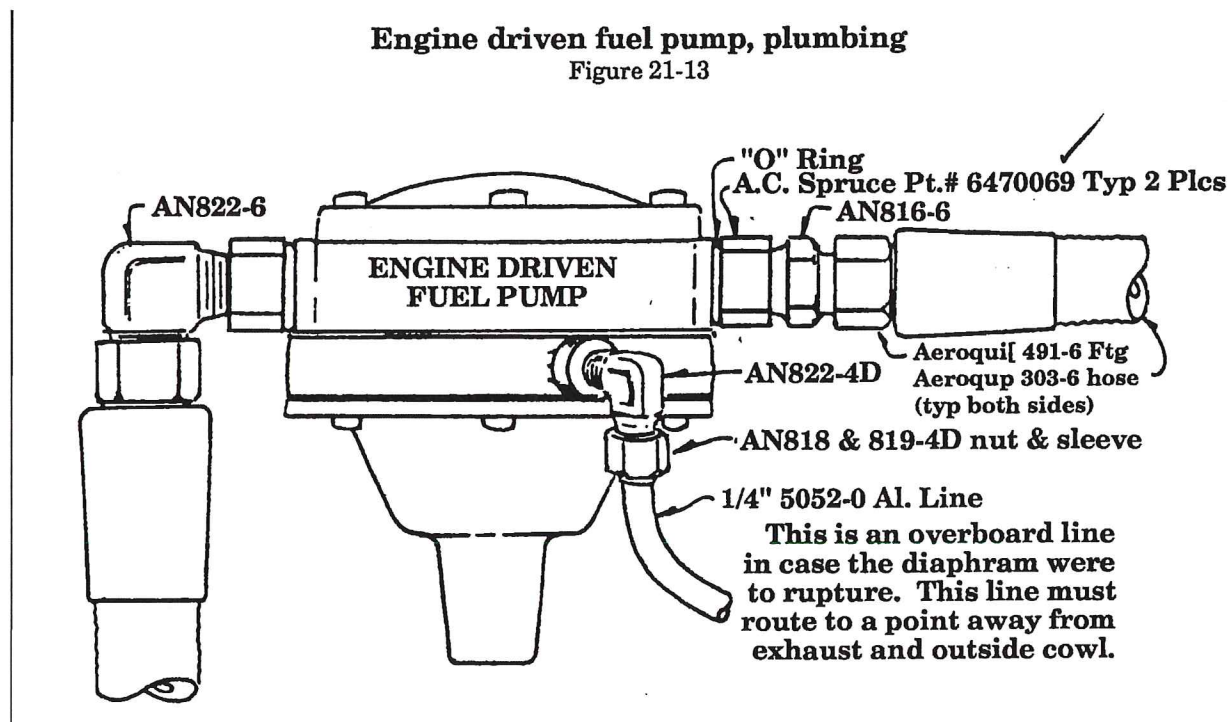
Figure 4

The Lancair Construction Manual calls out steel fittings, elbow part number AN822-6 and nipple part number AN816-6. (Lancair 320FB, Chapter 21, p 21) Contrary to the Construction Manual, the fuel pump on the accident aircraft was installed using an aluminum fitting on the inlet side.

The following drawing is taken from Chapter 21 of the Construction Manual
